# WARTIME REPORT

FLIGHT MEASUREMENTS OF THE EFFECT ON ELEVATOR STICK FORCES

MEMORANDUM REPORT

By Harold I. Johnson and Robert G. Mungall

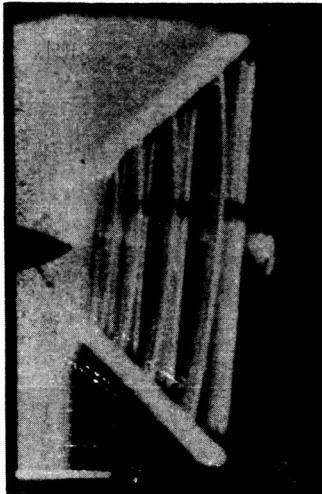
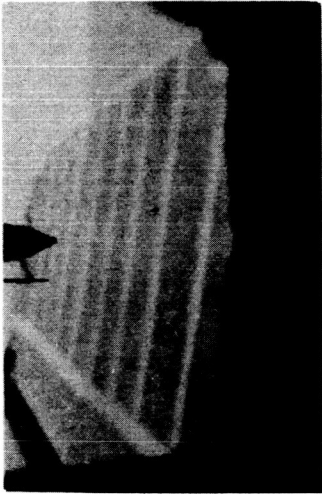
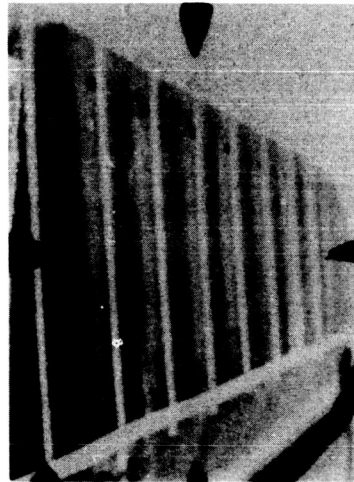
Figure 8.- Examples of photographs taken to investigate the effects of elevator fabric distortion.

- (a) Original P-63A-1 elevator in straight flight at  $V_i = 350$  mph. Elevator rib spacing  $8\frac{1}{2}$  inches.
- (b) Stiffened P-63A-1 elevator in straight flight at  $V_i = 350$  mph. Elevator rib spacing  $4\frac{1}{4}$  inches.

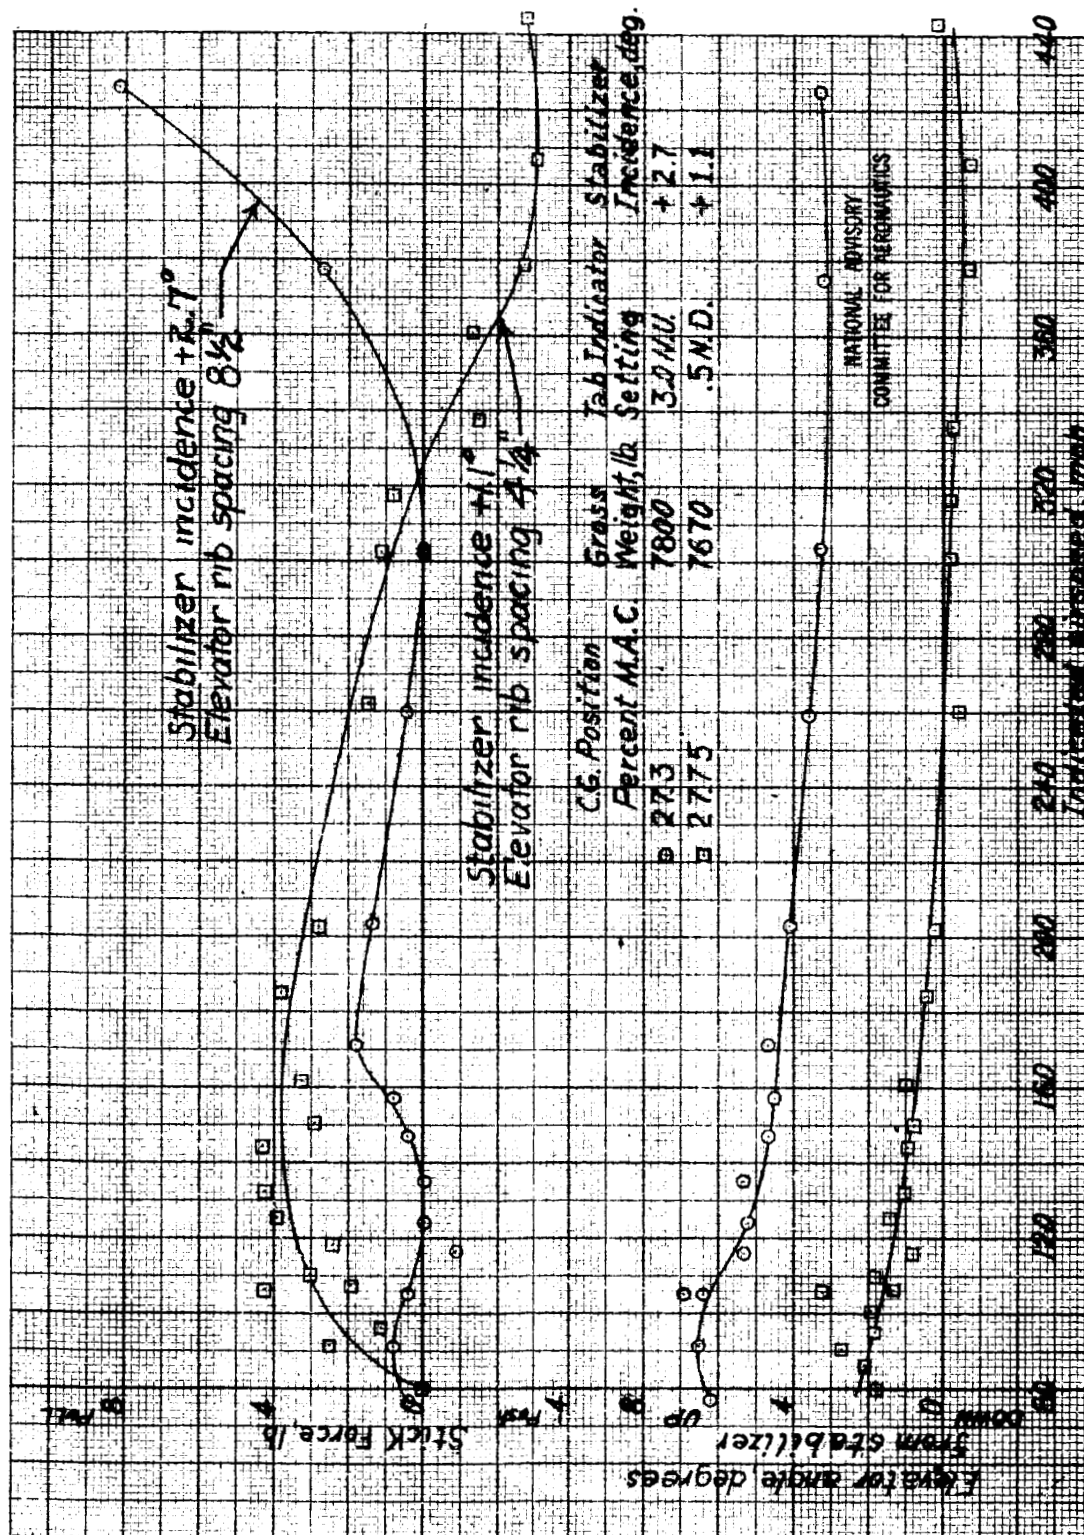
Figure 9 shows a comparison of the static longitudinal stability of the P-63A-1 airplane with normal rated power for comparable center-of-gravity locations with the two different stabilizer incidence and elevator rib spacing combinations tested. Figure 10 is a similar plot for the engine-idling condition. Figures 9 and 10 show that two important effects resulted from decreasing the stabilizer incidence and reducing the elevator rib spacing. First, with the stabilizer set  $2.7^\circ$  up from the thrust axis, the elevator angle for trim in high-speed straight flight was over  $3^\circ$  up from the stabilizer; whereas, with the stabilizer set  $1.1^\circ$  up from the thrust axis, the elevator angle for high-speed trim was about  $0.5^\circ$  down from the stabilizer. Second, increasing pull stick forces with increasing speed were necessary to maintain trim at high speed with the high incidence  $8\frac{1}{2}$ -inch rib-spaced elevator combination; whereas, with the low incidence  $4\frac{1}{4}$ -inch rib-spaced combination, push stick forces were required to maintain trim throughout the high-speed range tested. Tests made at the Bell Aircraft Corporation showed that increasing the number of elevator ribs decreased the magnitude of the pull stick forces which occurred with the stabilizer set  $2.7^\circ$  up from the thrust axis. The installation of a metal-covered elevator further reduced the magnitude of the pull stick forces which occurred with the original incidence of  $2.7^\circ$  up from the thrust axis but did not cause the force variation with speed to follow a stable trend. Therefore, test data indicate the departure from a stable variation of the stick force versus speed curve was associated with the excessively high stabilizer setting. It is believed that this high stabilizer setting affected the manner of distortion of the elevator covering and possibly resulted in twisting the stabilizer at high speeds.

Figure 9. - Data showing the effect of stabilizer incidence setting and elevator rib spacing on the static longitudinal stability characteristics of the P-63A-1 airplane. Clean condition, normal rated power (2600 RPM, 43 in. Hg), altitude range 5-10,000 feet.

2. Stick-free stability was improved to a satisfactory degree by lowering the stabilizer incidence from  $2.7^\circ$  to  $1.1^\circ$  up from the thrust axis and by changing the elevator rib spacing from  $8\frac{1}{2}$  inches to  $4\frac{1}{4}$  inches.

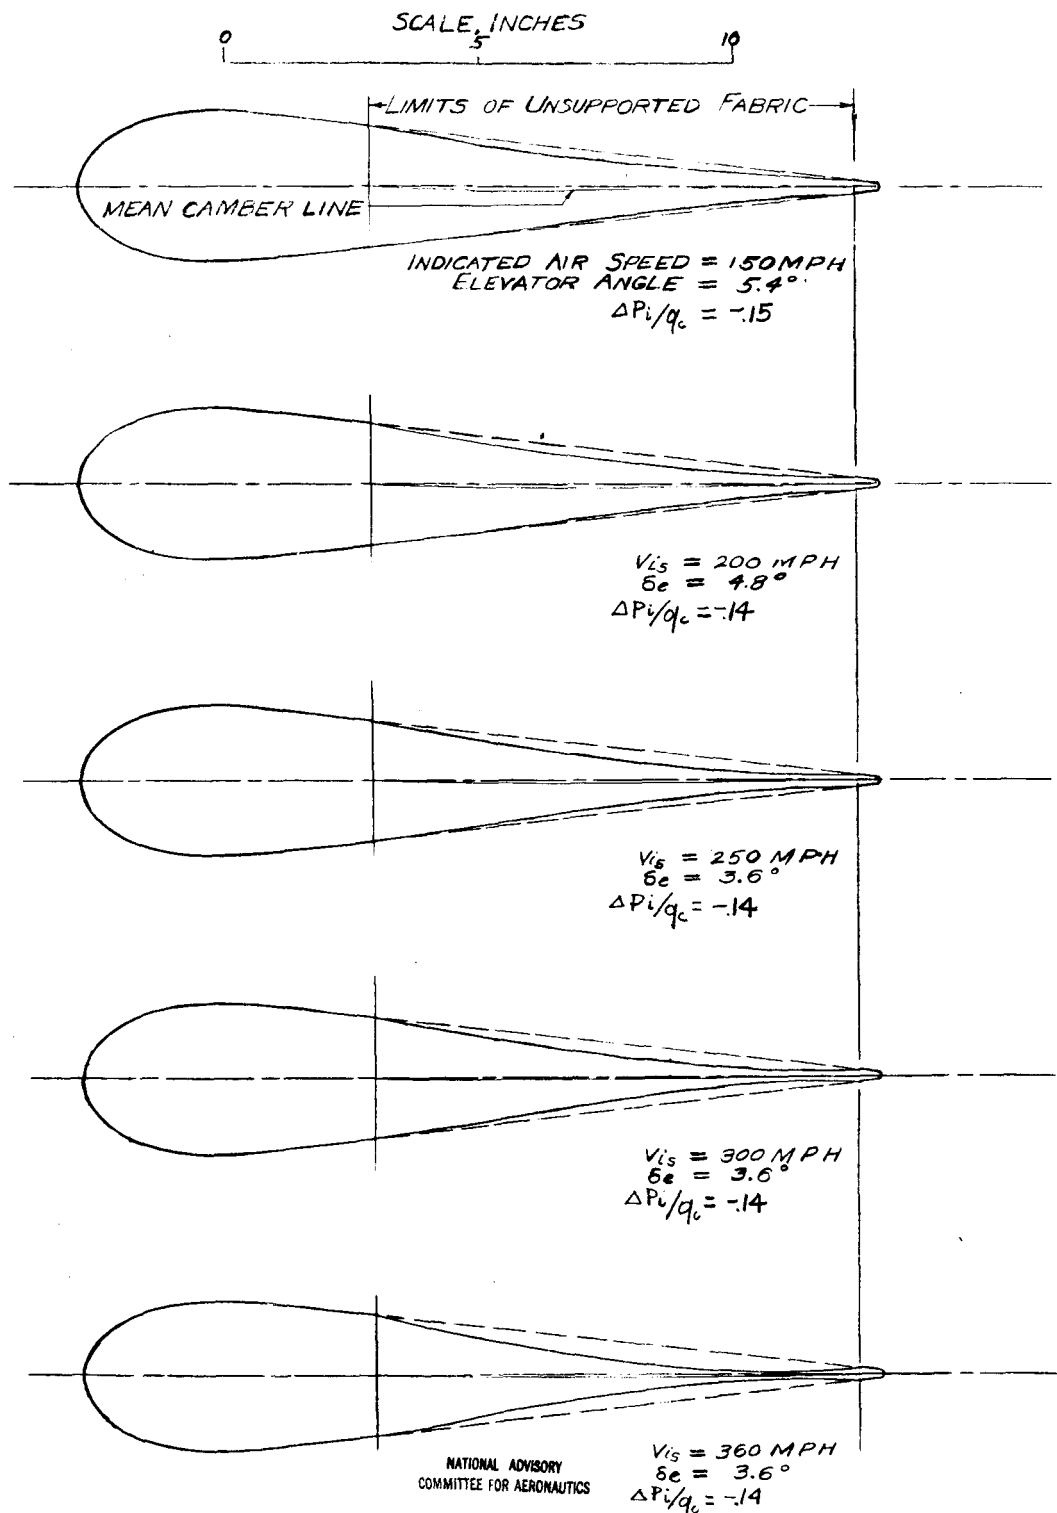
Further information on the contribution of fabric distortion to the undesirable stick-force variation with speed is provided by the data shown in figure 11 which shows the variation of elevator section shape with speed for the  $8\frac{1}{2}$ -inch rib-spaced elevators with the stabilizer incidence  $2.7^\circ$  up from the thrust axis, as determined from gun camera photographs. The fabric distortion characteristics shown by figure 11 may be explained as follows:

1. The fabric on both upper and lower surfaces bowed inward (cusped) under the influence of the negative internal pressure. Since the elevator internal pressure remained at about 14 percent of the free-stream impact pressure below free-stream static pressure, the amount of fabric deflection tended to vary approximately linearly with indicated airspeed. Such a variation is to be expected because although the pressure on the fabric increases as the square of the speed, the resistance of the fabric panel to deflection increases rapidly at large fabric deflections (reference 2). That the variation of fabric deflection (cupping) with indicated airspeed was approximately linear is borne out by the data shown in figure 15, wherein the maximum fabric deflections of the upper and lower surfaces are plotted against indicated airspeed.

2. The elevator mean camber line was bowed downward slightly due to the air load on the elevator. Since up elevator was required to trim the airplane at high speed on account of the high stabilizer incidence, the air load on the elevator was probably downward and the mean camber line was therefore depressed.

Progressive cupping of the elevator might cause the elevator hinge-moment coefficients  $C_{h\alpha}$  and  $C_{h\delta}$  to become more negative with increasing speed in such a manner as to shift the stick-free neutral point forward. If the stick-free neutral point moved past the center-of-gravity position, an unstable variation of stick force with speed would be expected. Bowing of the elevator mean camber line in a downward direction might cause a change in hinge moment in the direction such that pull stick forces are required as the speed increases.

FIGURE 11. - ELEVATOR SECTIONS AT CENTER OF PANEL NUMBER 4 (FIGURE 3) SHOWING THE VARIATION OF FABRIC DEFLECTION WITH INDICATED AIRSPEED AT AN ACCELERATION OF  $1g$ . ELEVATOR ANGLES ARE GIVEN WITH RESPECT TO STABILIZER. (+ = UP); STABILIZER INCIDENCE  $2.7^\circ$  ELEVATOR RIB SPACING  $8\frac{1}{2}$  INCHES. ELEVATOR INTERNAL PRESSURE GIVEN AS FRACTION OF CORRECT IMPACT PRESSURE BELOW CORRECT STATIC PRESSURE.

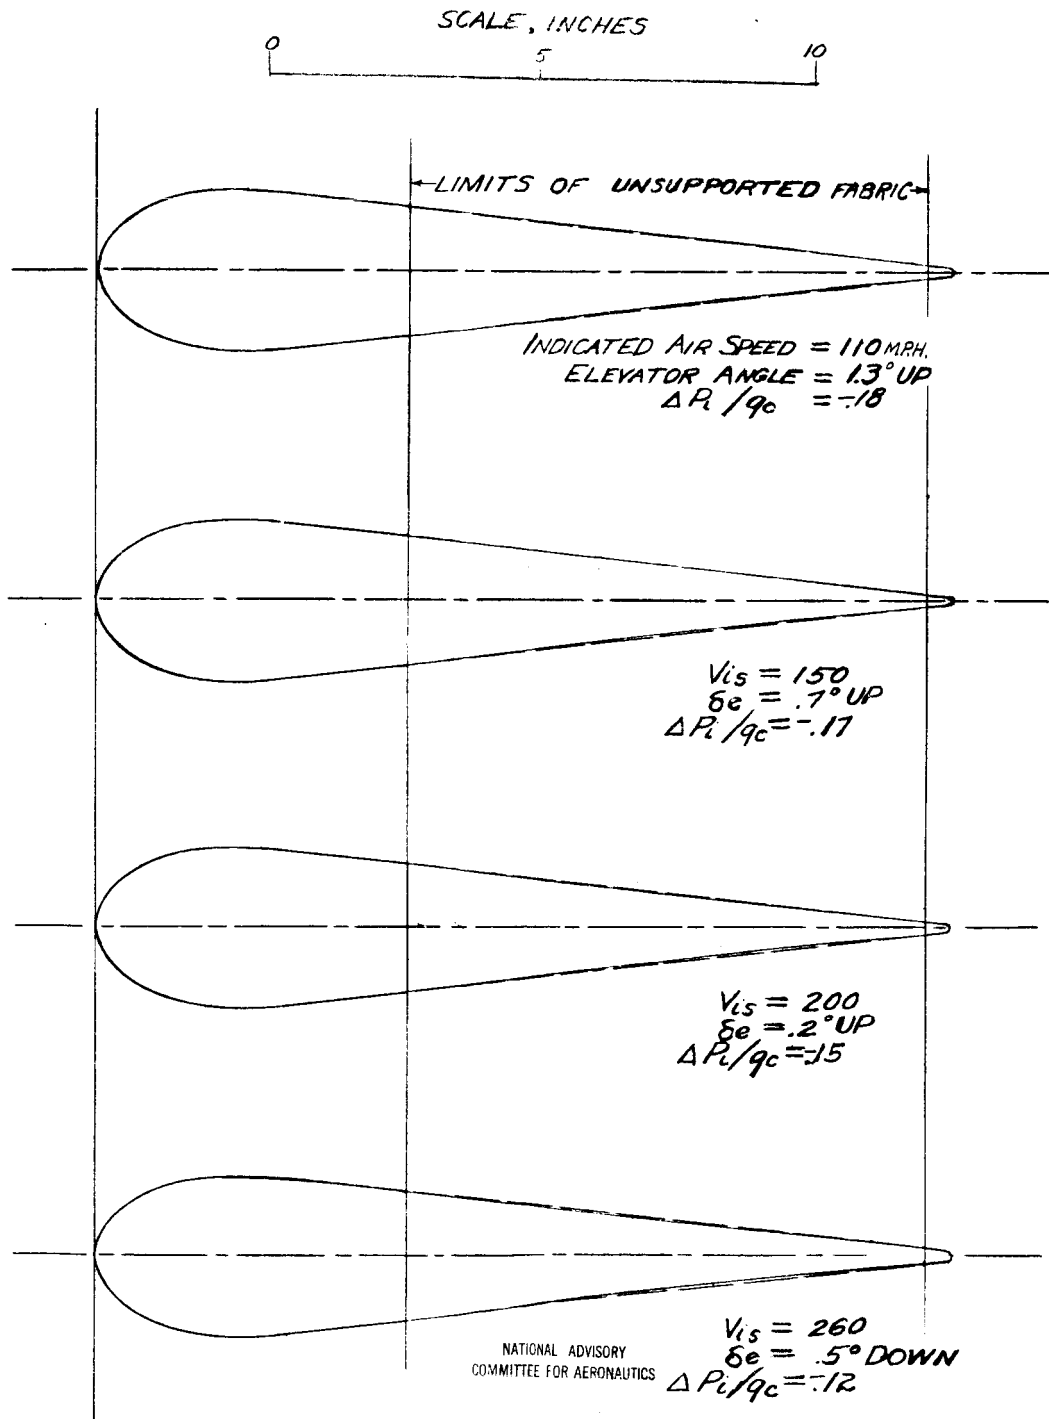
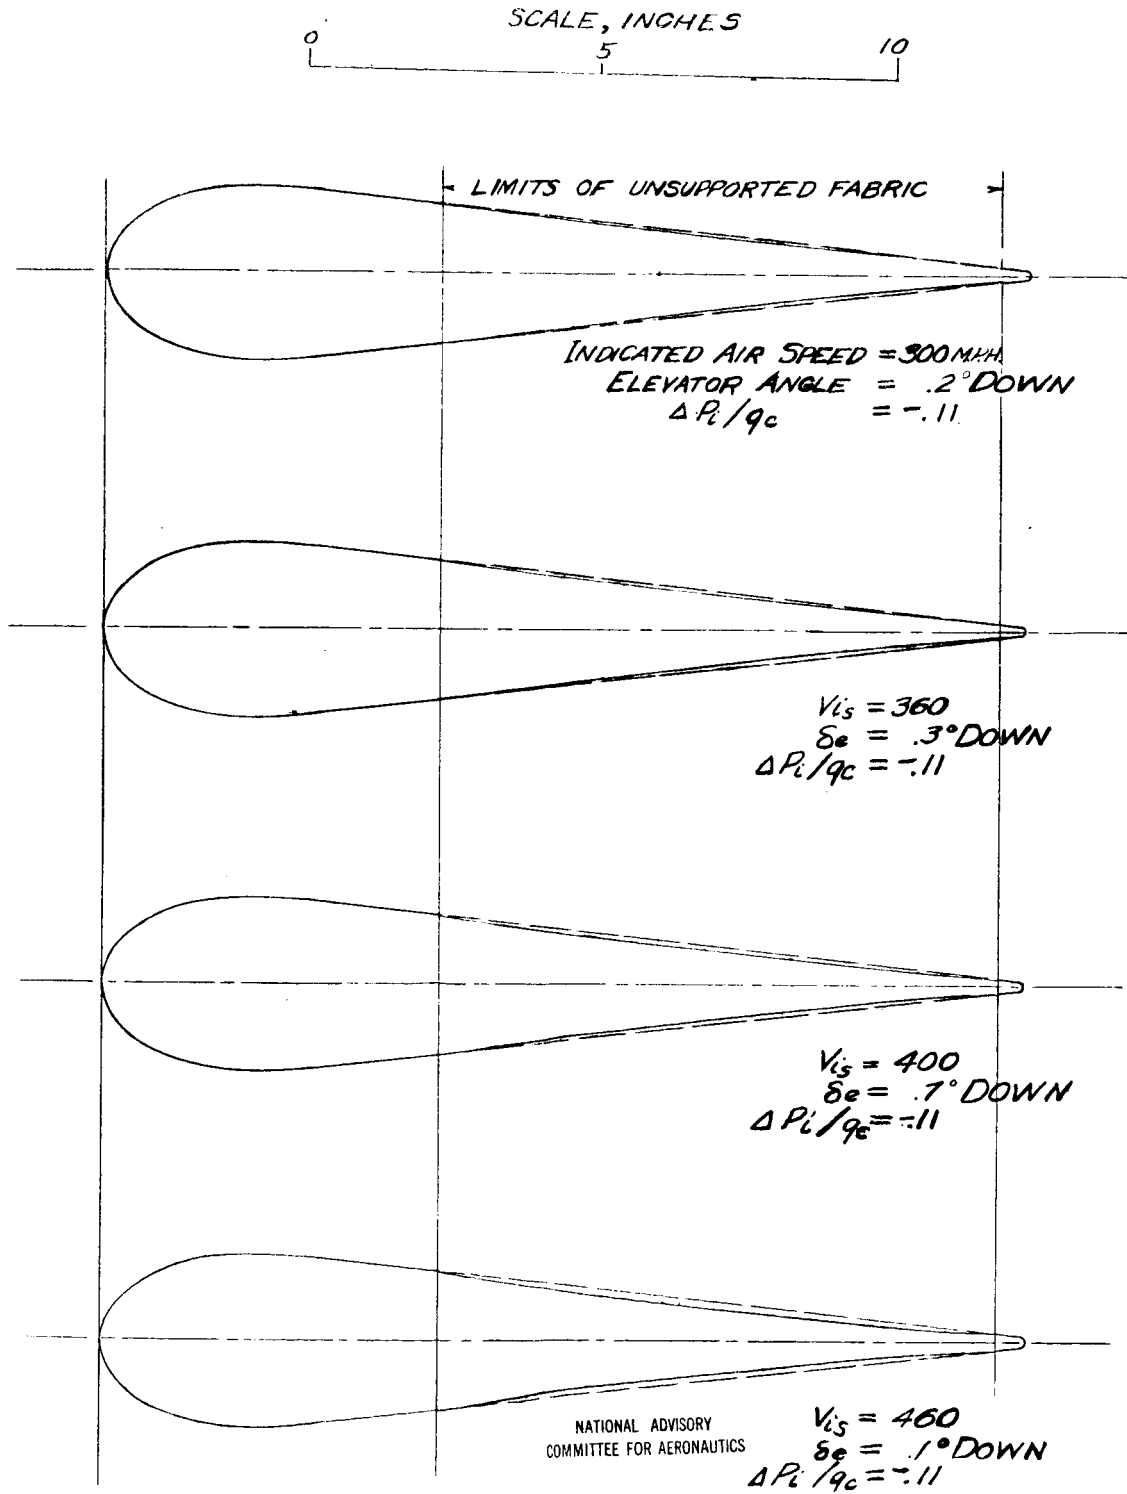
Figure 12 shows the distortion characteristics through the speed range of the  $\frac{1}{4}$ -inch rib-spaced elevators with the low stabilizer incidence of  $1.1^\circ$  up from the thrust axis. The internal pressure for this elevator was about 11 percent of the free-stream impact pressure

below free-stream static pressure at high speeds. Examination of the maximum fabric deflection which occurred with these elevators at high speeds (fig. 15) shows that at the highest speed for which comparable data are available ( $V_{is} = 360$  mph) the deflection was only about one-fourth as great as it was for the original  $8\frac{1}{2}$ -inch rib-spaced elevators. This large reduction in fabric distortion is to be expected because theory indicates that for constant pressure differential the maximum fabric deflection in a panel should vary approximately as the square of the unsupported gap distance. Warping of the mean camber line of the  $4\frac{1}{4}$ -inch rib-spaced elevators at high speed was scarcely discernible so that the elevator mean camber lines are omitted in figure 12. The absence of curvature of the mean camber line would be expected because the elevator air load at high speed should be small when the elevator is approximately aligned with the stabilizer for straight flight trim.

FIGURE 12.- ELEVATOR SECTIONS AT CENTER OF PANEL NUMBER 7 (FIGURE 4) SHOWING THE VARIATION OF FABRIC DEFLECTION WITH INDICATED AIRSPEED IN STRAIGHT FLIGHT. ELEVATOR ANGLES ARE GIVEN WITH RESPECT TO STABILIZER. STABILIZER INCIDENCE +1.1°. ELEVATOR INTERNAL PRESSURE MEASURED AT PANEL NUMBER 7 IS GIVEN AS FRACTION OF CORRECT IMPACT PRESSURE BELOW CORRECT STATIC PRESSURE. ELEVATOR RIB SPACING 4 1/4 INCHES.

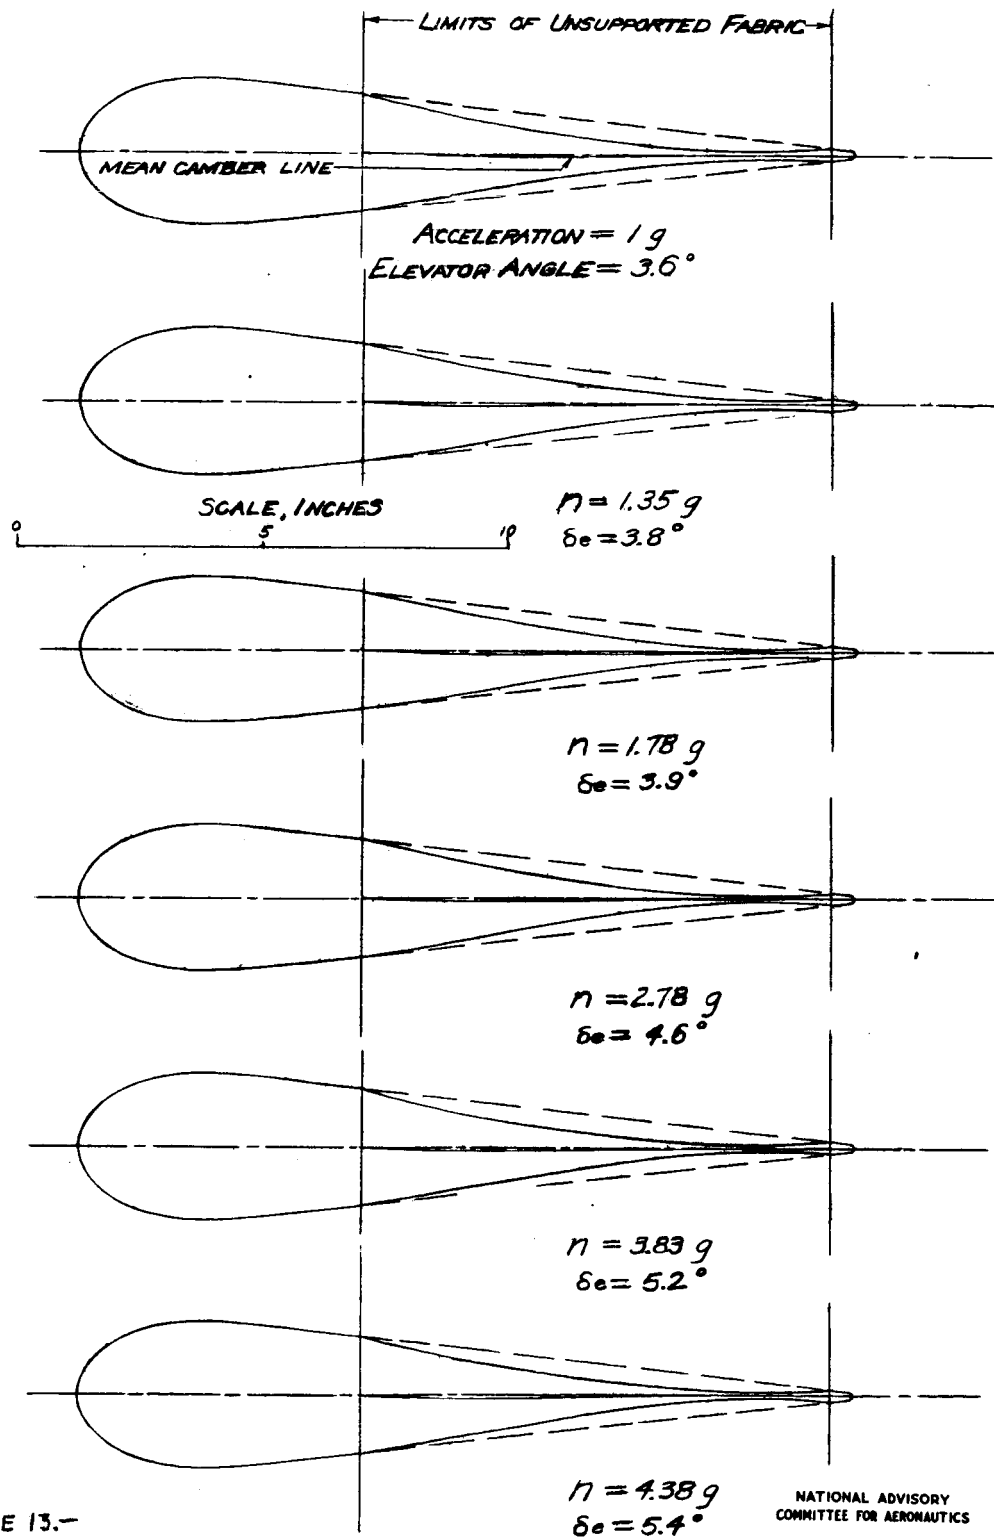
FIGURE 13.-

Figure 13 represents a series of elevator section shapes measured in turns at  $V_{is} = 360$  miles per hour with the  $8\frac{1}{2}$ -inch elevator rib-spaced,  $2.7^\circ$  up from the thrust axis, stabilizer incidence combination. Figure 14 is a similar plot for the  $4\frac{1}{4}$ -inch elevator rib-spaced,  $1.1^\circ$  up from the thrust axis stabilizer incidence combination at  $V_{is} = 300$  miles per hour. In both cases the center

of gravity was at 27.5 percent mean aerodynamic chord. These figures indicate the amount of fabric deflection and warping of the elevator mean camber line was independent of normal acceleration or elevator angle at constant indicated airspeed, for the range of elevator angles used in these turns. There was no measurable difference between the variations of stick force with acceleration for the two stabilizer incidence, elevator rib-spacing combinations tested. For this reason the data are not shown. Both combinations tested had normal variations of stick force against acceleration up to 5g acceleration at constant indicated airspeeds below 360 miles per hour.

ELEVATOR SECTIONS AT CENTER OF PANEL NUMBER 4 SHOWING THE VARIATION OF FABRIC DEFLECTION WITH ACCELERATION AT AN INDICATED AIRSPEED OF 360 M.P.H. ELEVATOR ANGLES ARE GIVEN WITH RESPECT TO THE STABILIZER ( $\pm$  UP) STABILIZER INCIDENCE  $2.7^\circ$ . ELEVATOR RIB SPACING  $8\frac{1}{2}$  INCHES.

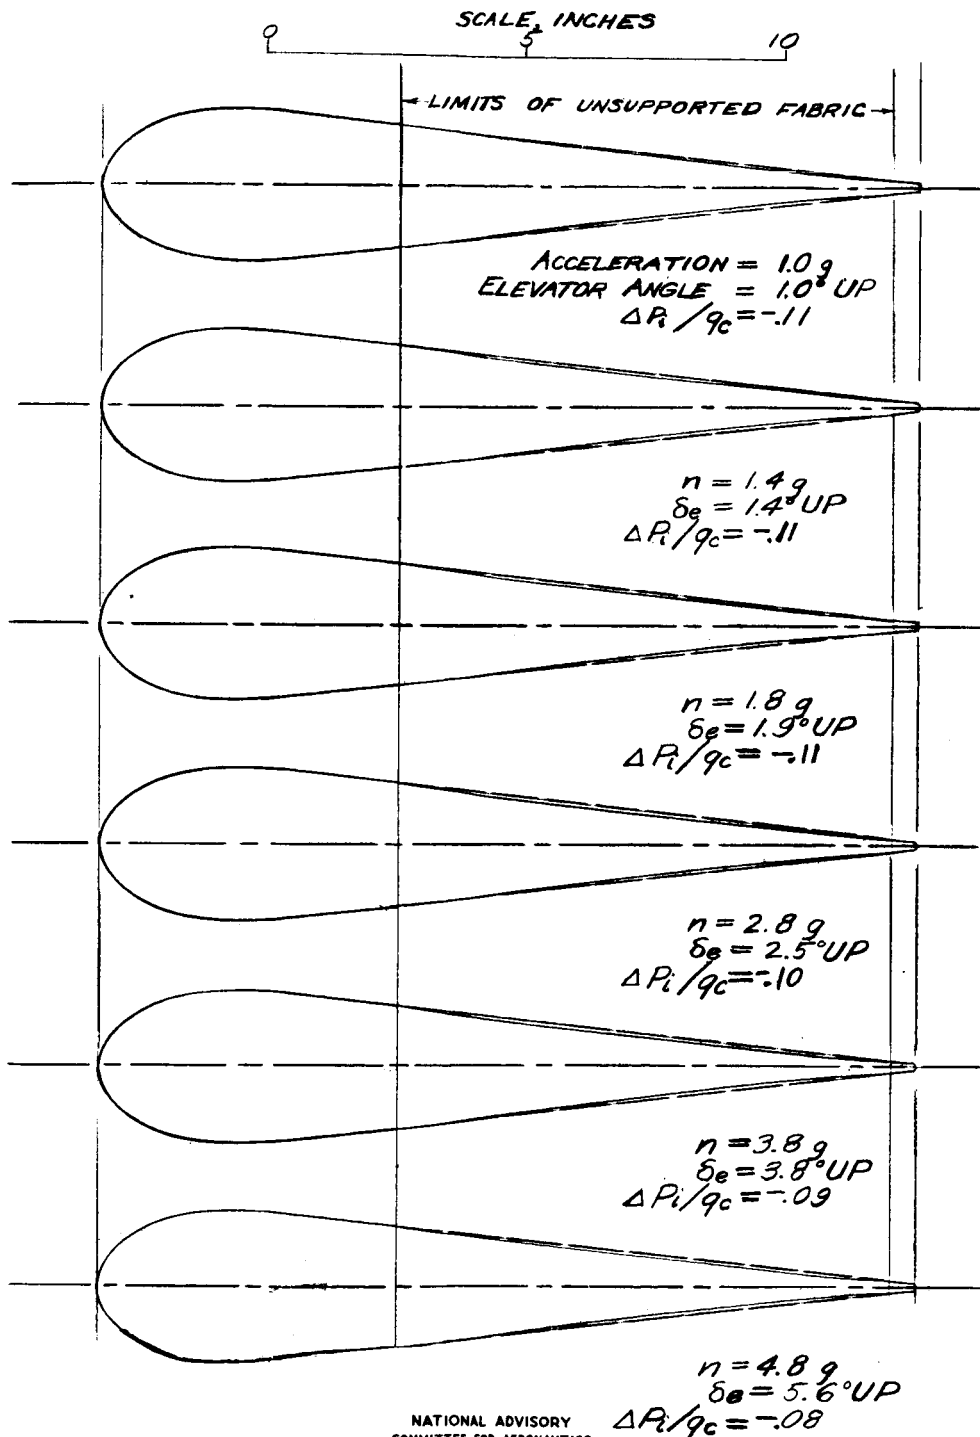
FIGURE 14.—ELEVATOR SECTIONS AT CENTER OF PANEL NUMBER 7 (FIGURE 4) SHOWING THE VARIATION OF FABRIC DEFLECTION WITH ACCELERATION AT AN INDICATED AIRSPEED OF 300 M.P.H. ELEVATOR ANGLES ARE GIVEN WITH RESPECT TO STABILIZER. STABILIZER INCIDENCE +11°. ELEVATOR INTERNAL PRESSURE MEASURED AT PANEL NUMBER 7 IS GIVEN AS FRACTION OF CORRECT IMPACT PRESSURE BELOW CORRECT STATIC PRESSURE.

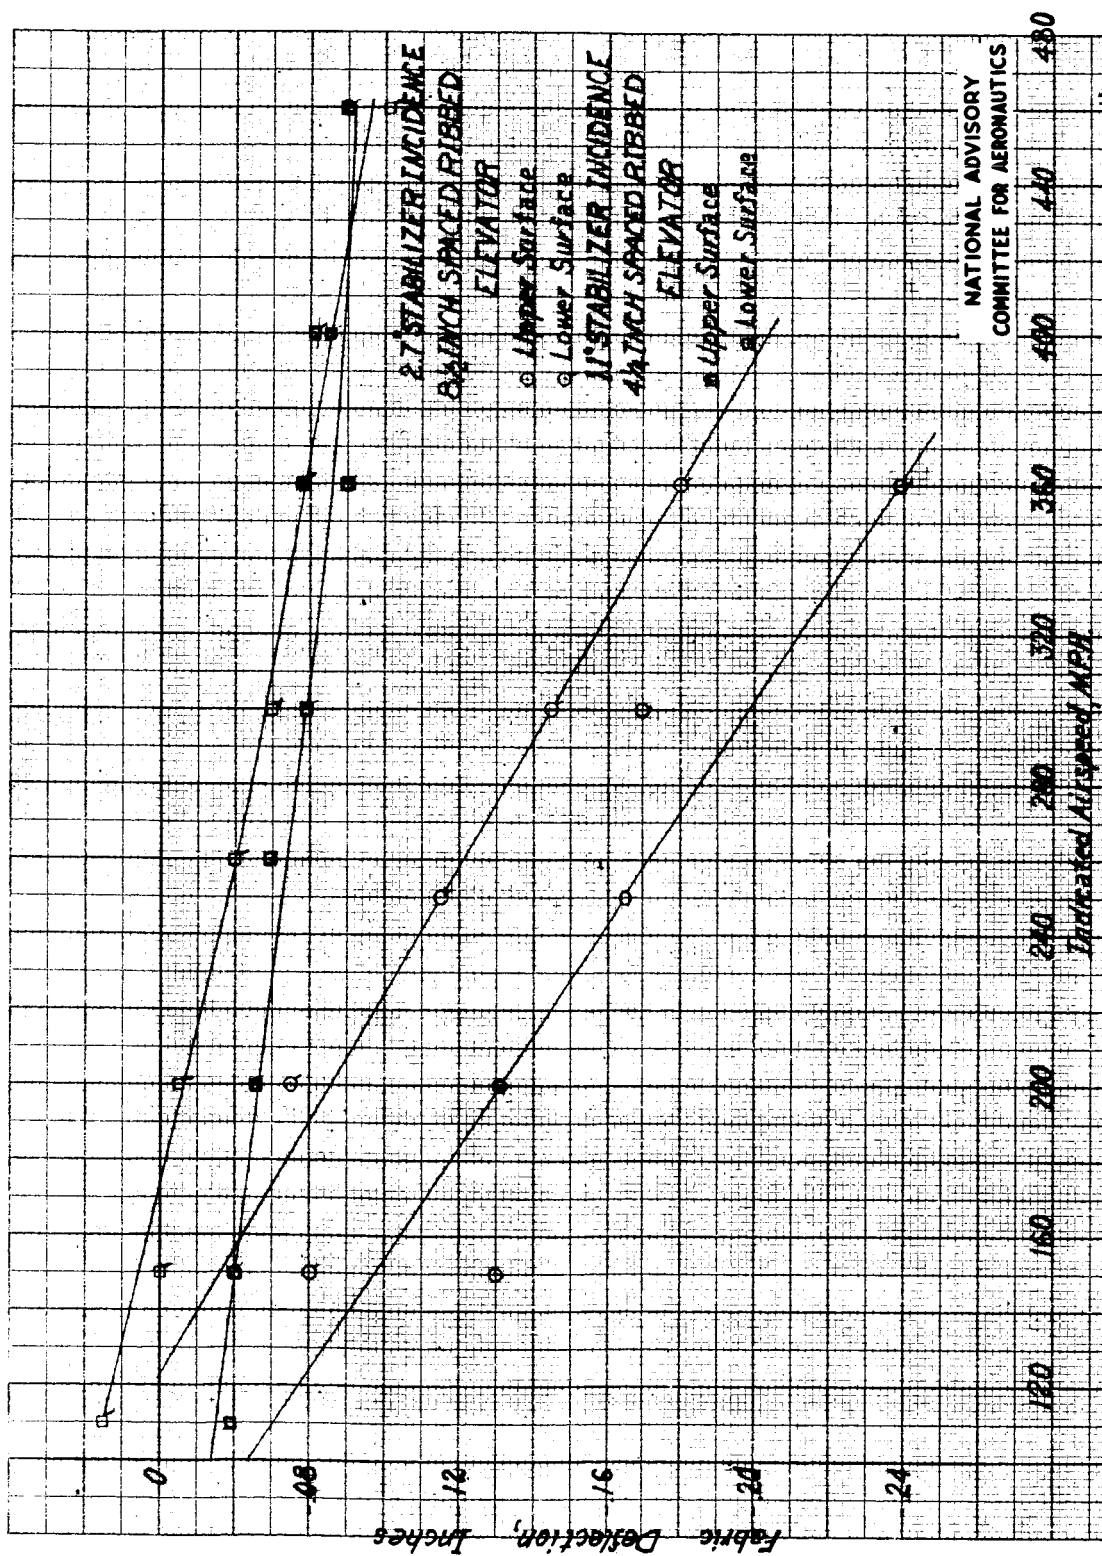
It is of interest to note that the accuracy with which fabric contours can be duplicated from 16-millimeter film is probably indicated by the scatter of the data shown in figure 15. In this connection the large relative scatter in the data for the  $8\frac{1}{2}$ -inch rib-spaced elevators as compared to the data for the  $4\frac{1}{4}$ -inch rib-spaced elevators is believed to be explained by the quality of the photographs obtained in the two sets of tests. The first tests were made with the  $8\frac{1}{2}$ -inch rib-spaced elevators and considerable blurring was encountered in the pictures of the upper surface (see also fig. 8). For the second tests with the  $4\frac{1}{4}$ -inch rib-spaced elevators the blurring was largely eliminated by stiffening the upper-surface camera mount.

Figure 15.- Maximum fabric depression from figures 11 and 12 plotted against indicated airspeed.

3. Maximum deflection of the fabric elevator covering at high speed was reduced to about one-fourth its previous amount by reducing the rib spacing of the original elevators from  $8\frac{1}{2}$  inches to  $4\frac{1}{4}$  inches, and by reducing the stabilizer incidence from  $2.7^\circ$  up from the thrust axis to  $1.1^\circ$  up from the thrust axis.
